# Engine bearing failures and how to avoid them

Dr. Dmitri Kopeliovich Research & Development Director

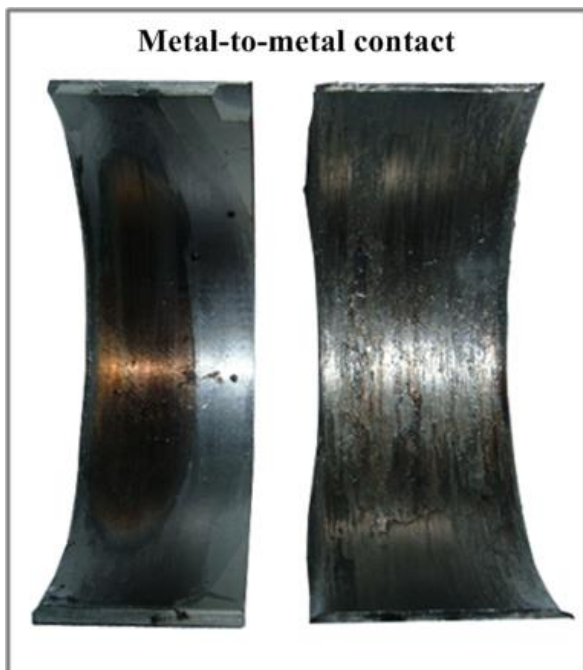
Fig.1 Metal-to-metal contact

Mixed lubrication is one of the main causes of engine bearing failures.

- **Accelerated wear** when the bearing is not overheated and only shining appearance of the bearing surface is observed.
- **Wiping or heavy wear**, which appears in form of signs of overheating and partial melting of the overlay (the left part of the Fig.1).
- **Severe wear or Hot Short** . It results in torn surface, heavy overheating, melted overlay and lining material (right part of the Fig.1).

<b>Bearing failures due to metal-to-metal contact</b>	
<b>Cause</b>	<b>Remedy</b>
Insufficient oil supply (oil starvation)	Check oil supply system (e.g. clean clogged oil passages ,insufficient clearance, etc)
Breaking the oil film (due bearing material fatigue)	Change bearing material (tri-metal instead of bi-metal ( or solve overloading problem
Misalignment (e.g. out-of-shape grinding, distorted connecting rod)	Correct deficient machining, fix/replace distorted parts ,use more conformable material (bi-metal instead of tri-metal)
Poor journal surface finish	Verify proper grinding/polishing procedures
Foreign particles embedded in the bearing surface	Determine origin of particles, improve cleaning procedures prior assembly, replace oil and filter more frequently
Low viscosity oil (diluted with fuel or coolant)	Identify/address source of oil dilution, use higher viscosity oil
Grinding chatter marks (waviness) and lobing	Check crank grinder table + wheel bearings for excessive play, replace/re-grind crankshaft

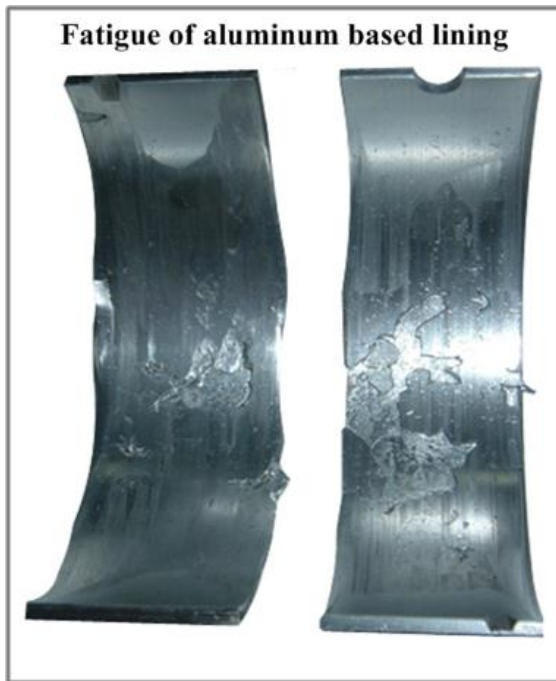
Fig.2 Fatigue of aluminum lining of bi-metal bearings

**Fatigue of an aluminum lining.** The fatigue cracks form on the surface and propagate inside the lining reaching the steel back.

The cracks then progress along the bond line between the lining and the steel.

Pieces of the lining flake out from the steel back resulting in the engine failure.

Fatigue of aluminum alloys may also cause extrusion of the lining material out of the bearing edges.

<b>Engine bearing failures due to fatigue</b>	
<b>Cause</b>	<b>Remedy</b>
Wrong selection of engine bearing material	Change to a bearing material with higher load capacity (e.g. tri-metal instead of bi-metal)
Fuel detonation / advanced ignition	Retard ignition or use a fuel with higher octane number
Running engine at high torque and low RPM for a long time (climbing)	Change to bearing material with higher load capacity (e.g. tri-metal instead of bi-metal)
Poor conforming of the bearing back with the housing surface	<ol style="list-style-type: none"> <li>1. Check the bearing crush height</li> <li>2. Properly re-size the housing</li> </ol>
Oil starvation causing localization of load at particular bearing areas	Check oil supply system for clogged oil passages, check clearances, component geometry, oil pressure + volume
Geometry misalignments causing localization of bearing loading	Fix/replace distorted parts or use more conformable material (bi-metal instead of tri-metal)

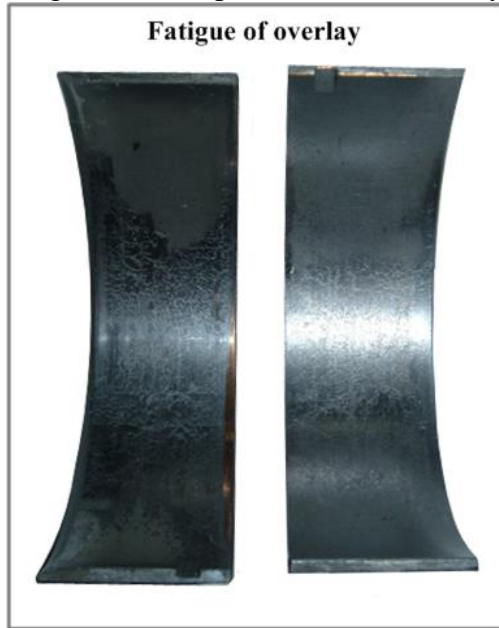
Fig.3 Fatigue of the overlay of tri-metal bearings

- **Fatigue of a tri-metal overlay.** Spider web like cracks are seen on the surface (Fig.4). Fatigue limit of an overlay is determined by the strength of the material and the thickness of the overlay. The thinner the overlay the higher its fatigue strength.

Overlay fatigue itself does not cause the engine failure.

However running the bearing with fatigued overlay may cause partial flaking of the overlay and lowering the oil film thickness and after some time – seizure or

fatigue of the exposed intermediate layer.

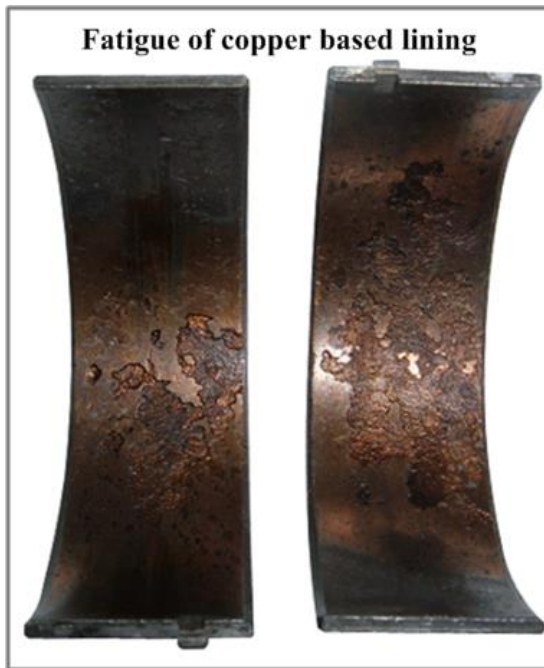
Fig.4 Fatigue of the copper based intermediate layer of tri-metal bearings

- **Fatigue of a copper based intermediate layer.** Fatigue of a copper based lining (Fig.4) starts from a fatigue of the overlay. The overlay flakes out from the copper lining resulting in breaking the oil film and breaking the hydrodynamic lubrication regime. The load localizes at the contact area causing formation of small cracks on the lining surface. The cracks then propagate throughout the lining thickness, meet the steel back surface and continue to advance along the steel-copper boundary. As a result parts of the intermediate layer detach from the steel surface.

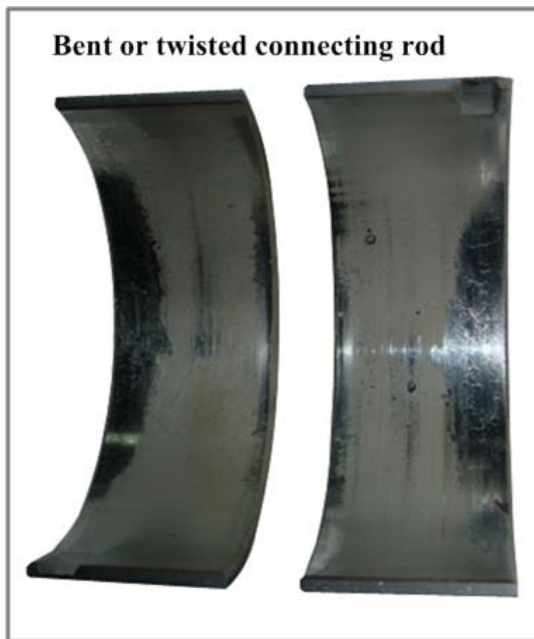
Fig.5 Bent or twisted connecting rod

Fig.5 and 6 present examples of the effect of geometric irregularities. Both discussed problems are seen in the picture: local wear with shining appearance and the overlay fatigue in form of spider web like cracks on the areas of metal-to-metal contact.

- **Distorted (bent or twisted connecting rod)** is one of the causes of localized loading of engine bearings (Fig.5).  
Overloading of an internal combustion engine due to detonation or running under high torque at low rotation speed may cause distortion of the connecting rods. The distortion results in non-parallel orientation of the bearing and journal surfaces.  
The non-parallelism causes localized excessive wear of the bearing surface due to metal-to-metal contact (boundary or mixed lubrication) occurring near the bearing edge.  
Localized metal-to-metal contact may also cause fatigue cracking of the bearing material in the locations of the contact.

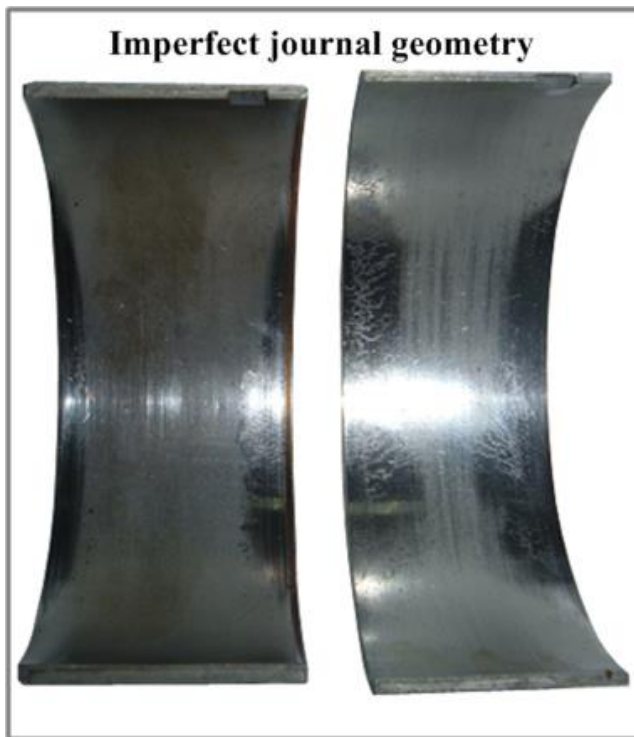
Fig.6 Imperfect journal geometry

- **Imperfect journal geometry** is another cause of localized loading of engine bearings (Fig.6).  
Use of a worn stone in grinding a crankshaft results in obtaining an imperfect (out-of-shape) journal surface: taper shape, hour glass shape or barrel shape. The parts of the journal surface having higher diameter (central part of the barrel

shape journal, edge parts of hour glass shape journal) come to metal-to metal contact (boundary lubrication) with the bearing surface.  
The metal-to-metal contact causes excessive wear.  
Fatigue cracking of the bearing materials may occur in the contact areas.

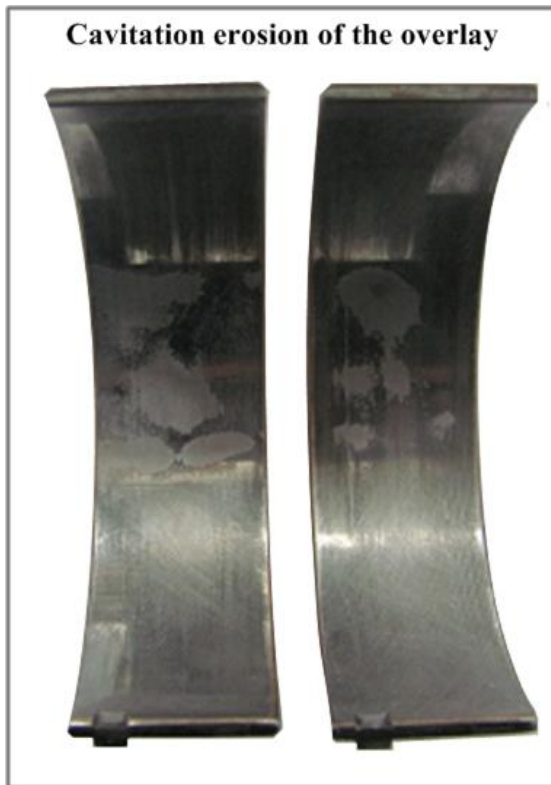
Fig.7 Cavitation erosion of soft lead based overlay

Cavitation occurs when the load applied to the bearing fluctuates at high frequency (high RPM). The oil pressure instantly falls causing formation of bubbles (cavities) due to fast evaporation. When the pressure rises the cavitation bubbles contract at high velocity. Such collapse results in impact pressure, which may erode the bearing material (Fig.7).

Soft lead based overlays of tri-metal bearings are prone to the cavitation erosion.

Therefore replacement of tri-metal bearings with babbitt overlay with bi-metal material or with high strength tri-metal bearings (e.g. GP) will prevent the failures due to cavitation.
