# Engine Bearing Failure Analysis Guide

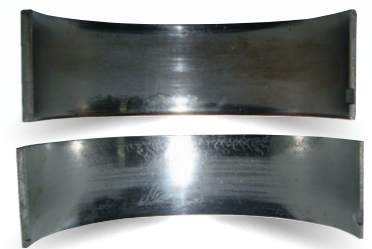
## Imperfect Journal Geometry

Localized wear in parts of the bearing surface. Fatigue cracks may occur in these areas.

- Inconsistent journal diameter. Areas of greater diameter produce metal-to-metal contact with the bearing surface, causing local wear
- Use of worn or improperly dressed grinding wheel when resizing the crankshaft. Journals may result as tapered, hourglass shape or barrel shape

- Replace/redress grinding wheel
- Re-grind the crankshaft

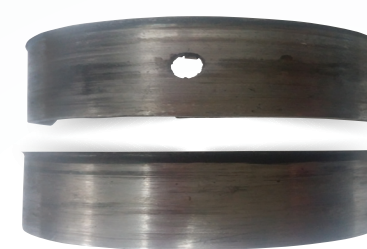
## Spinning of the Bearing in the Housing

Highly polished area on the bearing back caused by bearing spinning in the housing.

- Insufficient crush height
- Oil starvation/lugging the engine causing seizure
- Housing diameter greater than specified value

- Choose bearings with sufficient crush height for the application
- Eliminate the cause of seizure
- Check housing diameter for size and roundness
- Tighten bolts to the specified torque value
